# A Nondestructive Inspection System for the Inspection of Wear Surfaces in Tank Track Shoes

Valery F. Godínez-Azcuaga, Richard D. Finlayson  
Physical Acoustics Corporation

Basavaraju B. Raju  
U.S. Army Tank and Armaments Command

## ABSTRACT

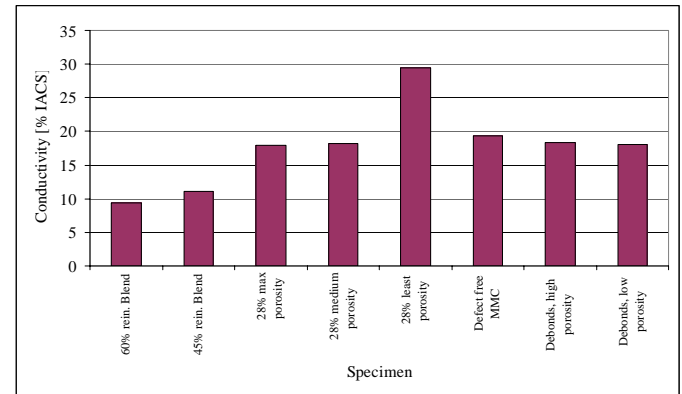
Point measurements were performed of the eight controlled-defect MMC specimens, and the results indicate the EC sensitivity to property variations as reinforcement and porosity content. Figure 1 shows the average conductivity of the specimens taken over 9 measurements on each specimen. Table 2 summarizes the results of the point EC measurements, and shows average conductivity and standard deviation, both in % IACS.

Figure 1. Conductivity measurements (point by point) on control defect specimens.

The results shown in Figure 1 and Table 2 indicate that increasing the porosity decreases the average conductivity. The porosity changes from 29.45% IACS for the specimen with lowest porosity (specimen 5) to 17.92% IACS for the specimen with highest porosity (specimen 3). The medium porosity specimen (number 4) has a conductivity of 18.3% IACS.

The data reveal that increasing the reinforcement blend decreases the average conductivity. This is observed from the drop in conductivity from greater than 17% IACS for the 28% reinforcement blend specimens, to 9.6% IACS for the 60% reinforcement blend specimen.

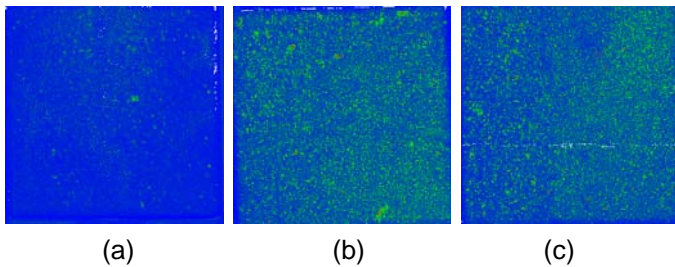
Figure 2 shows C-Scan images of specimen number 5 with minimum porosity, specimen number 4 with medium porosity, and sample 3 with high porosity. The images shown represent data taken from the region between the front and back walls of the samples, and so represent the distribution of porosity in the specimen. As can be seen in Figure 2(a) (specimen # 5) there are no prominent defects seen (shades of color other than blue, especially green and red) in the specimen with low porosity. This indicates that there were no features in the interior of the specimen that gave reflections between the front and back wall, which is expected from low porosity in the volume of the specimen.

Figure 2. Ultrasonic C-scan images of controlled-defect specimens bulk reflections: (a) Specimen 5 (low porosity), (b) Specimen 4 (medium porosity), (c) Specimen 3 (high porosity).

As can be seen from Figure 2(b) (specimen #4), there is a rather uniform distribution of damage throughout the specimen with medium porosity. It is important to note that the damage here is representative of the entire volume of the insert, and the different damage spots correspond to varying depths. There is a clear distinction from Figure 2(a) (specimen # 5), which produced a very clean image.

Figure 2(c) (specimen #3) shows an ultrasonic C-scan image of the specimen with the maximum amount of porosity. Again, there is a relatively large amount of damage visible in this picture. As mentioned before, it is important to keep in mind that this damage is representative of the entire volume of the specimen.

The critical point to note here is the similar amounts of porosity visible in both specimens 3 and 4, although they had been thought to contain different amounts of

porosity. This result corroborates the eddy current measurements discussed earlier. Visual inspection of the ultrasonic image provides no indication of any such distinction. From the EC measurements, we observed that specimens 3 and 4 had conductivity values of 17.92% IACS and 18.28% IACS, and the difference is less than the standard deviation of the measurement as indicated in Table 2. This very similar value of the measured conductivity is reflected in the similar amount of porosity seen in the ultrasonic images. A quantitative analysis of the images is needed to establish a precise correlation between EC and UT.

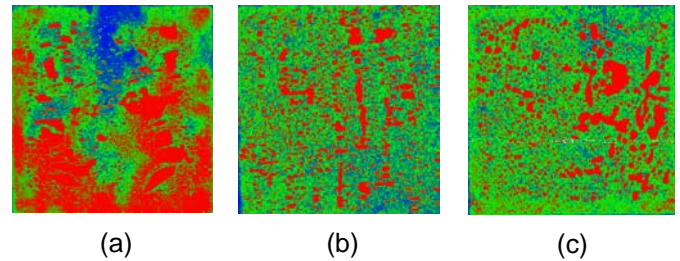
Figure 3 shows the images obtained by mapping the amplitude of the back wall echo from specimens 5, 4 and 3.

Figure 3. Ultrasonic C-scan images of controlled-defect specimens back-wall reflection: (a) Specimen 5 (low porosity), (b) Specimen 4 (medium porosity), (c) Specimen 3 (high porosity).

The red areas are the regions where the system detects a large reflection from the interface between the MMC and the aluminum substrate, indicating that there exists a region of high acoustic impedance mismatch, or in other words, debonds. Under good bonding conditions, the MMC-AI interface produces a relatively small reflection since the acoustic impedances of MMC and AI have very similar values. On the other hand, the presence of air in this interface results in a larger reflection. As can be seen, all three specimens have some debonds in the interface region, and specimen 5 in particular displays a large number of debonds. Again, specimen 5 showed the largest conductivity measurement (29% IACS), indicating the insensitivity of eddy current measurements to debonds.

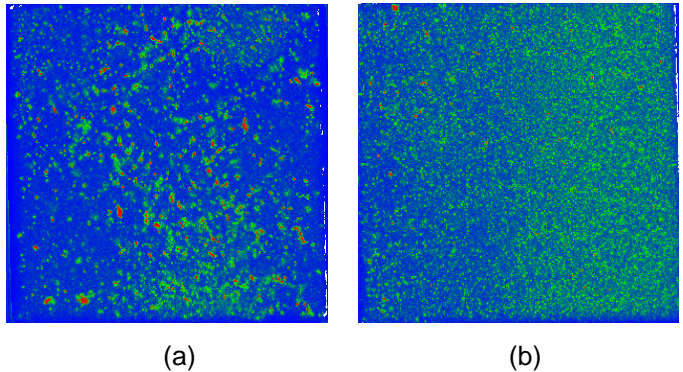
Figure 4 shows the ultrasonic C-scan images taken of specimens 7 and 8, the specimens with debonds, but containing different amounts of porosity. These images are from the interior of the specimen, and thus represent porosity damage. As can be seen from the images, the two specimens contain essentially the same amount of porosity, and there is little distinction between the 'high porosity' and 'low porosity' specimens. The main difference is that the high porosity specimen has larger spots of porous regions, distributed over a smaller area, whereas the low porosity specimen has smaller spots of

Figure 4. C-scan images of specimens with debonds, bulk reflections: (a) Specimen 7 with high porosity, (b) Specimen 8 with low porosity.

porosity, but distributed over the right hand side volume of the specimen. This almost identical amount of porosity indicated by the ultrasonic measurements explains why the EC measurements gave almost identical conductivity values for the two specimens, further corroborating those results. As in the case of specimens 3 and 4, a quantitative analysis of the UT C-scan images is necessary to establish a precise correlation with the EC measurements.

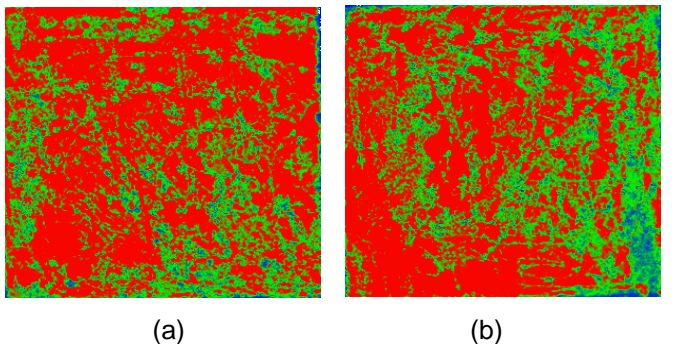
Figure 5 shows the ultrasonic C-scan images taken of the back wall echo of the MMC, showing the presence of

Figure 5. C-scan images of specimens with debonds, back wall reflection: (a) Specimen 7 with high porosity, (b) Specimen 8 with low porosity.

numerous debonds. There is clearly much more damage in this interface region compared to specimens 3, 4 and 5. Again, The presence of debonds does not affect the eddy current measurement, as eddy currents are inherently insensitive to their presence.

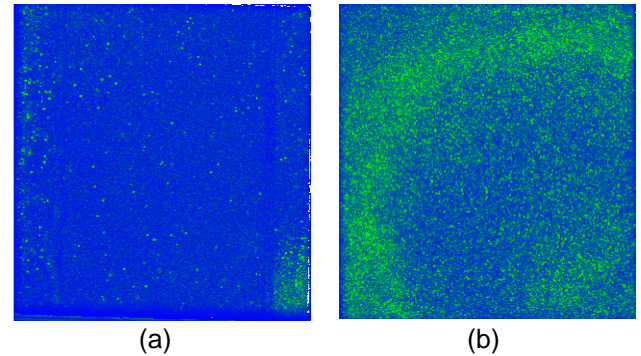
Specimens 1 and 2 were engineered to contain a higher percentage of reinforcement in the MMC insert. Figure 6 shows the ultrasonic images taken of the interior of the specimens. As can be seen from these images, specimen 2 has a high degree of porosity in the interior, whereas specimen 1 is relatively porosity free.

Figure 6. Ultrasonic C-scan of interior of specimens with different reinforcement volume fraction: (a) Specimen 1, with 60% reinforcement, (b) Specimen 2, with 45% reinforcement.

The eddy current measurements had indicated low conductivity values for both of the specimens in Figure

6, and there was some doubt as to the actual origin of this drop in conductivity. This can now be resolved by analyzing the results of the ultrasonic scans. The higher degree of porosity in specimen 2, coupled with a higher degree of reinforcement most likely gave the low value of conductivity in the eddy current measurement. Specimen 1, on the other hand, contains very little porosity, and the low conductivity value obtained arises solely due to the increased reinforcement content. Thus, the tandem inspection technique utilizing both EC and UT makes a comprehensive analysis of the specimen possible. A low value of conductivity measured with EC need not necessarily indicate porosity induced damage, but could mean a different reinforcement concentration and distribution. This can be verified by performing an ultrasonic C-scan, and correlating the damage found with the two techniques.

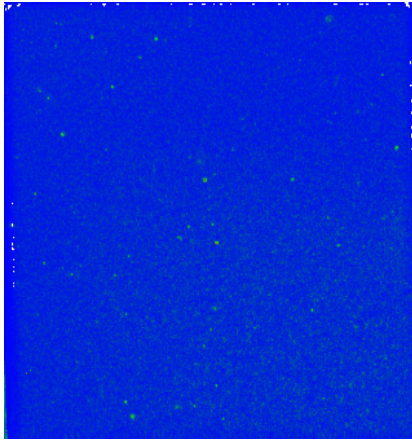
The supposedly defect-free specimen had an average conductivity of 19.3% IACS. This would mean that this specimen has either greater amounts of reinforcement or porosity (or both), that is pushing the effective conductivity down. The ultrasonic image helps in making a conclusion about the actual source of the lower conductivity. Figure 7 shows the ultrasonic image of this "defect-free" specimen.

Figure 7 Defect-free Specimen 6.

As can be seen, there is only a hint of porosity, and it is reasonable to make the conclusion that this specimen, while "damage" free, is still different from an ideal MMC reinforcement. This difference is most likely caused by

an increased reinforcement content that will not be detected in the ultrasonic C-scan image.

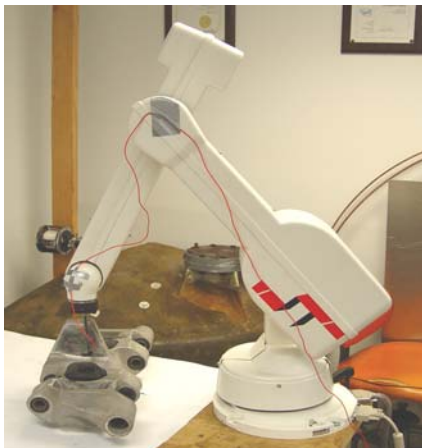
Figure 8. Robotic arm undergoing test at PAC.

The most likely approach to satisfy the mechanical requirements of the inspection system is a robotic arm with 5 degrees of freedom and probe changing capabilities.

An inspection system based on a robotic arm will offer great flexibility in terms of application of the UT/EC inspection technique to pieces of different geometries, therefore it would have great potential for its application in the automotive industry. Currently, a series of tests are being performed at PAC using the robotic arm shown in Figure 8.
